## A Legionnaire's Disease Cluster Investigation at a Recreational Spa Facility Session 8c (i)

*Megan Canright, MPH, CIH*  
*Forensic Analytical Consulting Services, Inc.*

# Case Study: Recreational Spa

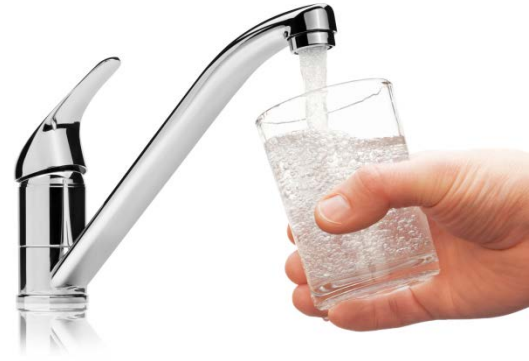
- Potable Water
  - DCW chlorine treated
  - DHW softened, rooftop boilers
  - Hot water circulating temperature 140°F+
  - Free chlorine residual non-detect
- Package HVAC units (no evap coolers)
- No irrigation
- Fire Sprinklers, no known cross connections

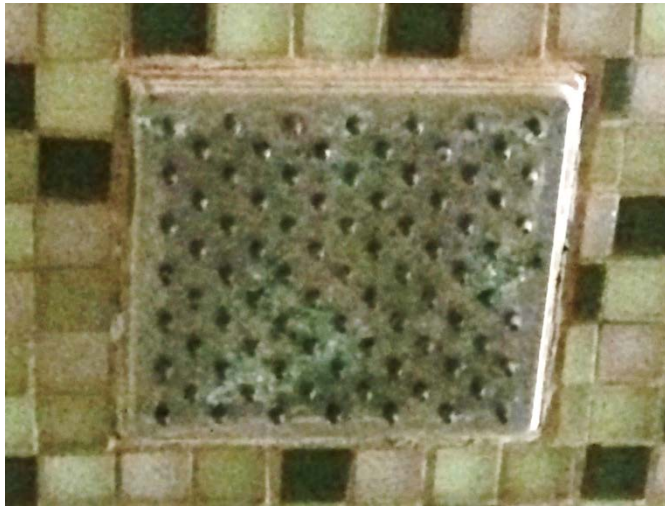
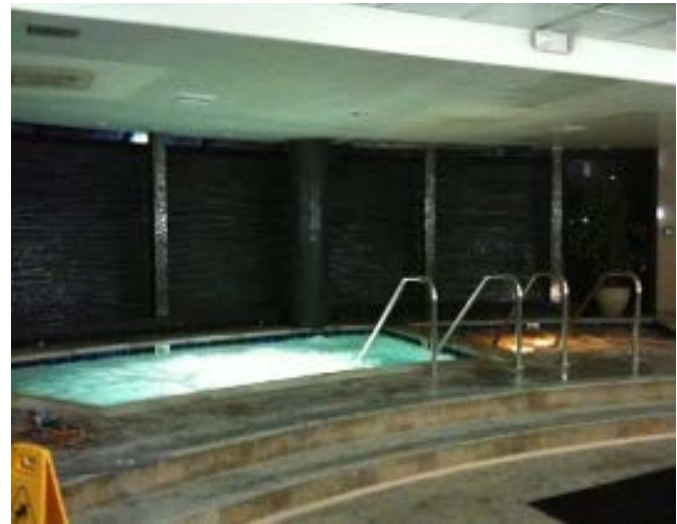
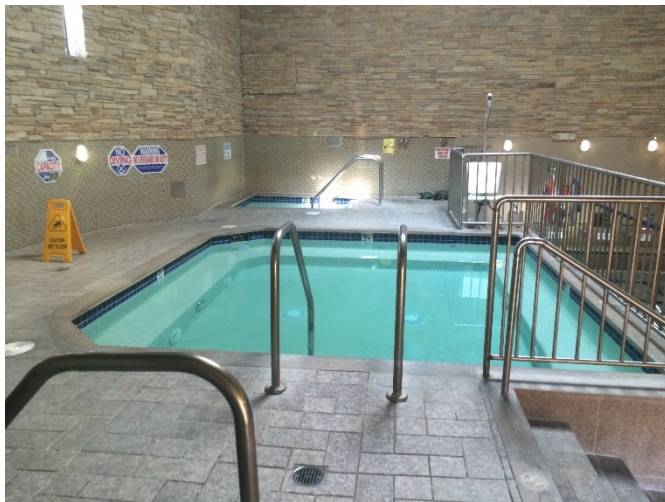
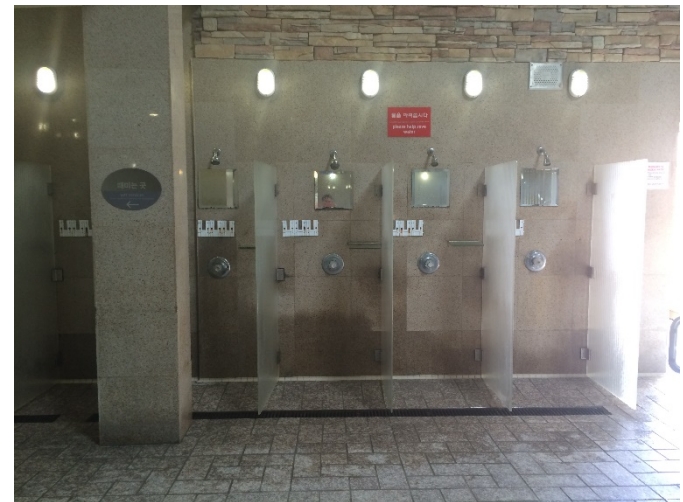
- 2<sup>nd</sup> Floor Men's/Women's Restrooms
- Men's standing showers
- Men's/Women's sauna showers

- Men's/Women's Warm Spas

- Women's Spa cascading fountain
- Men's/Women's Spas (all)

- Proactive primary treatment of water system (chlorine)
- Draining, cleaning, disinfection of all shower heads and all spas
- Draining, cleaning, disinfection of women's fountain
- Documented spa and fountain chlorination
- Flushing program for low-use fixtures
- Additional validation sampling
- Water management practices and written plan
- DPH – mandated POU filtration
- DPH – mandated secondary treatment
